**Coastal Protection and Restoration Authority  
(CPRA)**

## **2016 Operations, Maintenance, and Monitoring Report**

### **Clear Marais Shoreline Protection**

State Project Number CS-22  
Priority Project List 2

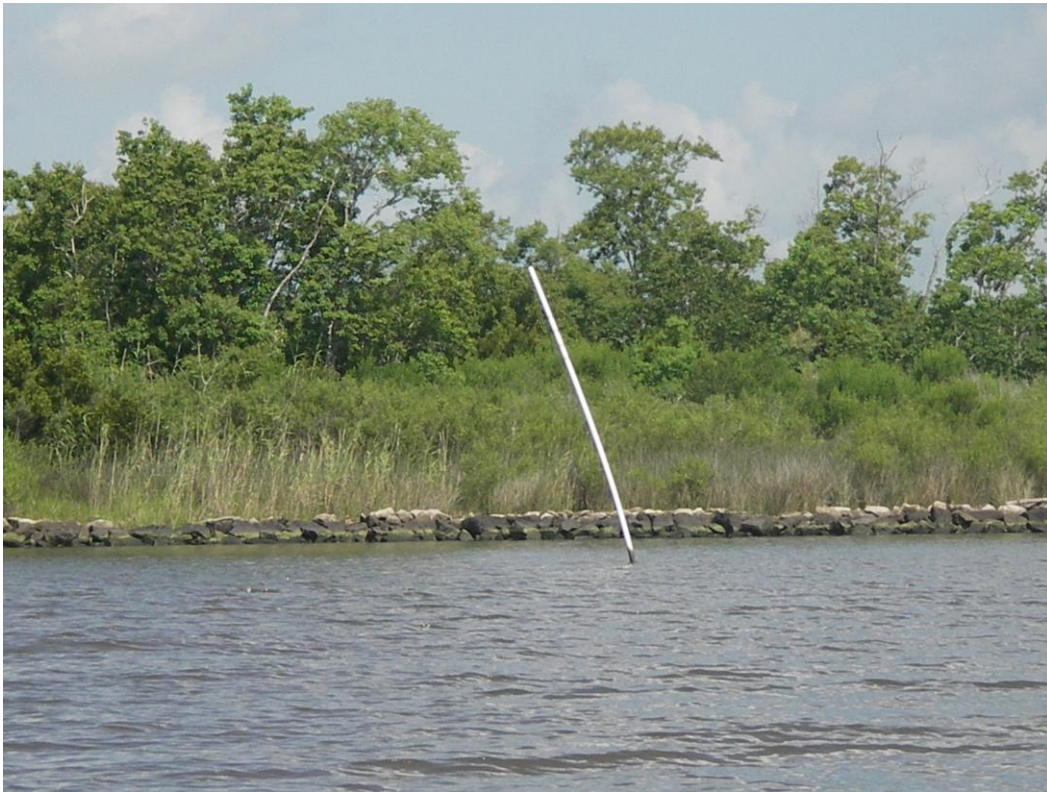
The dike is in good condition. As noted on previous inspections, approximately 4,000 to 5,000 linear feet of dike is below constructed elevation. This appears to be the result of slight settlement rather than displacement. Settlement of the rock dike has not worsened since originally noted and appears to have stabilized. There were two to three gaps approximately 30 feet wide where rock has been displaced by barges nosing up to the dike. These have also been noted on previous inspections and have not worsened or caused a negative impact on the project. Problems such as this are also noted on several other rock dikes along the GIWW. The dike is still functioning as intended and will continue to be monitored. There is no apparent need for any maintenance at this time. (Photos: Appendix A, Photos 1-2) Calcasieu Parish has constructed a rock dike using CIAP funding along the north side of the GIWW that tie into the western end on the CS-22 project. (Photo: Appendix A, Photo 3)

**Photo No. 1, Typical Rock Dike (June 13, 2013)**

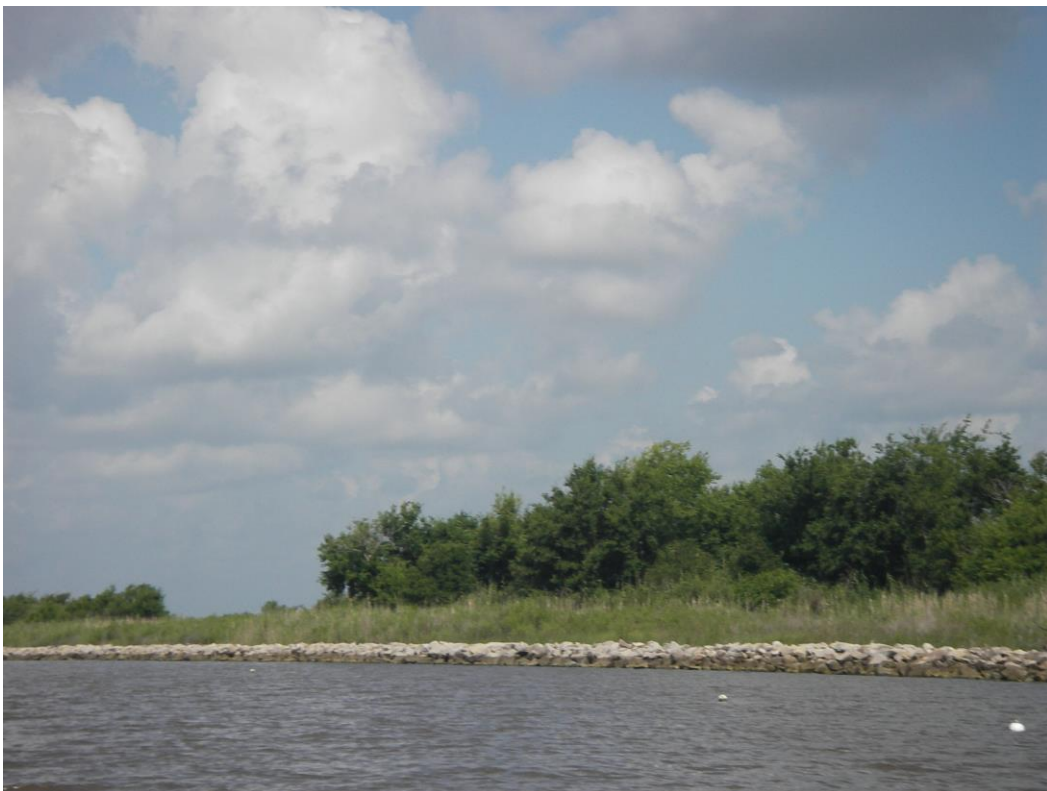
**Photo No. 2, Vegetation behind Rock Dike (June 13, 2013)**

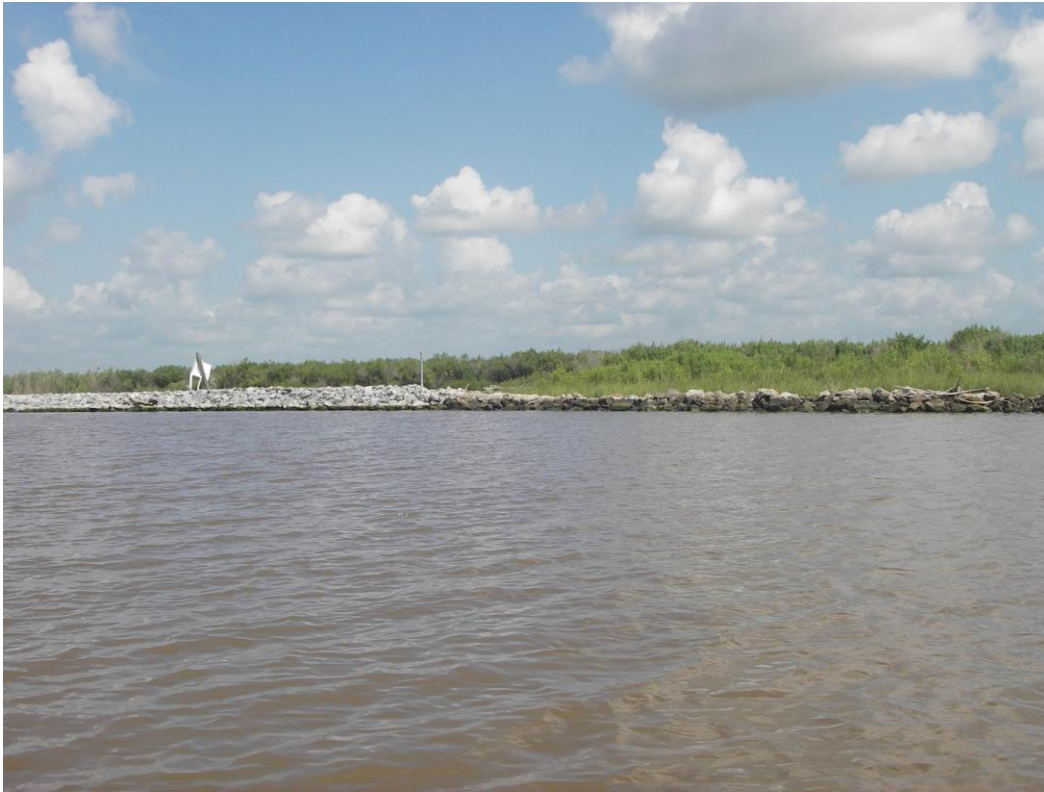
**Photo No. 3,** Connection at west end of CS-22 and Calcasieu Parish CIAP rock dike  
(June 13, 2013)
